LOOD PLAIN MANAGEMENT STUDY

MISTEGUAY CREEK GENESEE, SAGINAW AND SHIAWASSEE COUNTIES, MICHIGAN

OCTOBER 1989

**U.S. Department of Agriculture
Soil Conservation Service
East Lansing, Michigan**

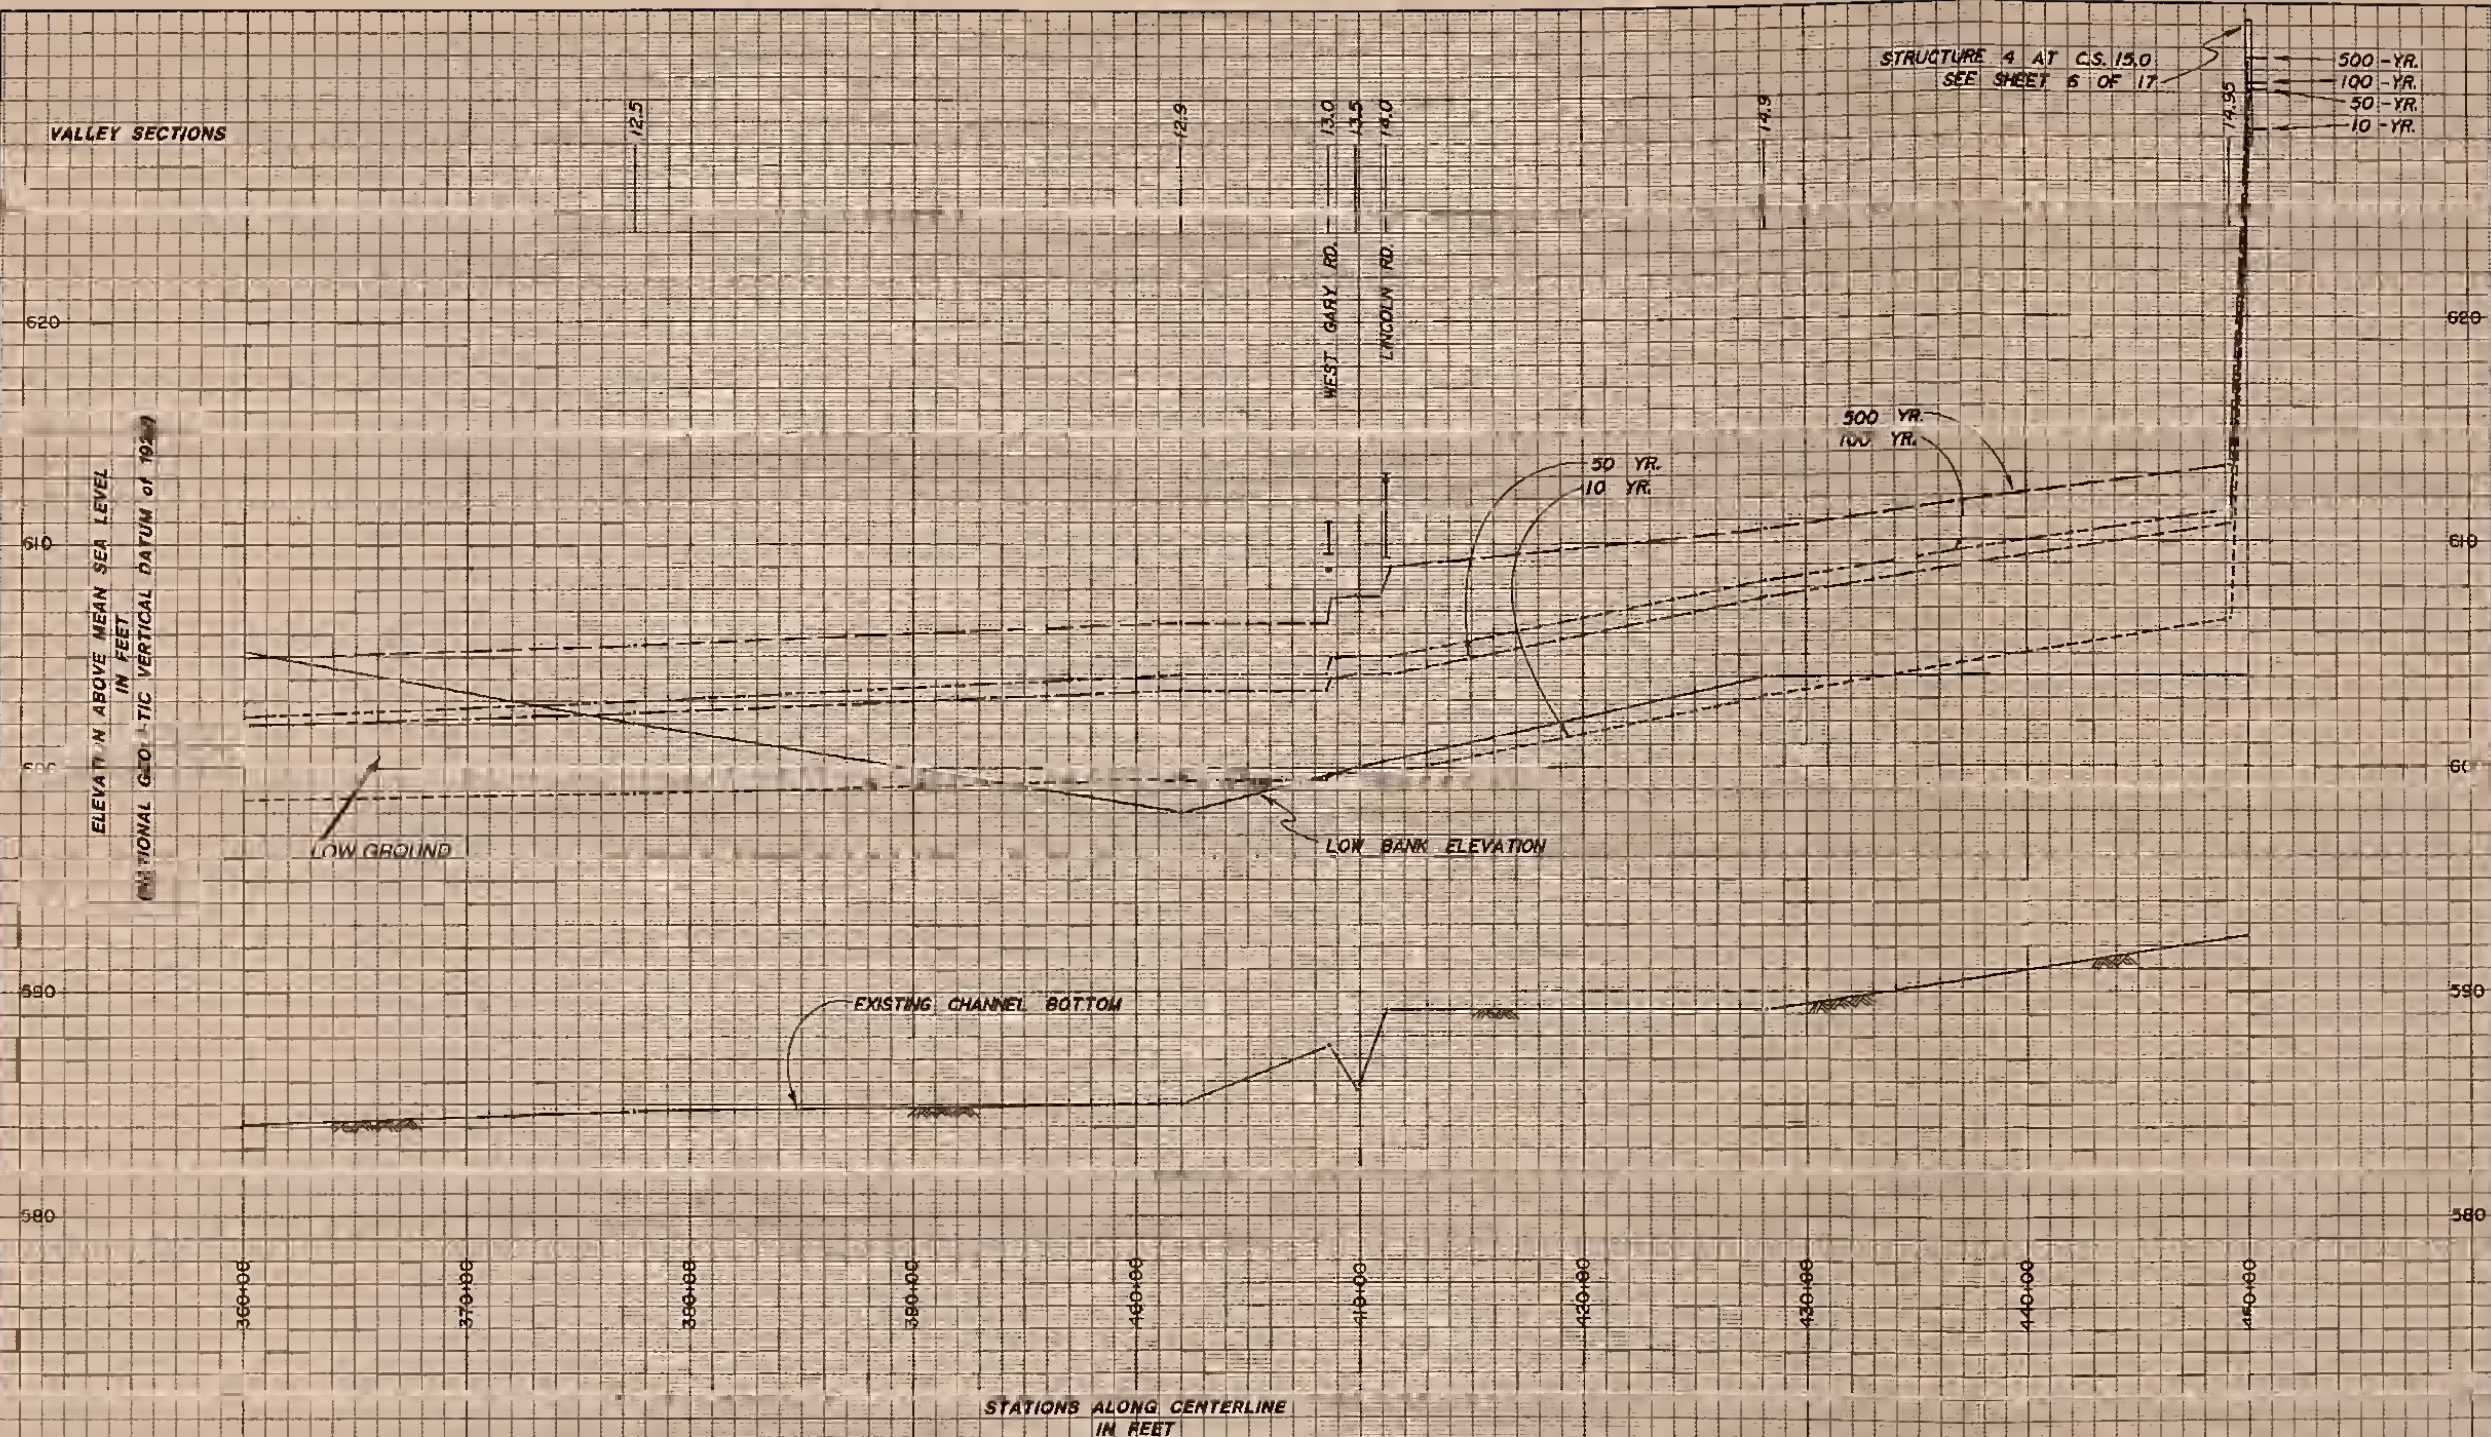
NOTE:
Additional field measured cross-sections may be needed to verify the water surface profile between the cross-sections used in this report. When the difference in the elevation of the channel bottom between cross-sections exceeds 2/3 the depth of flood flows, variations in the channel bottom can cause significant changes in the flood profiles.

HIGH WATER PROFILES MISTEGUAY CREEK FLOOD PLAIN MANAGEMENT STUDY GENESEE, SAGINAW AND SHIAWASSEE COUNTIES, MICHIGAN

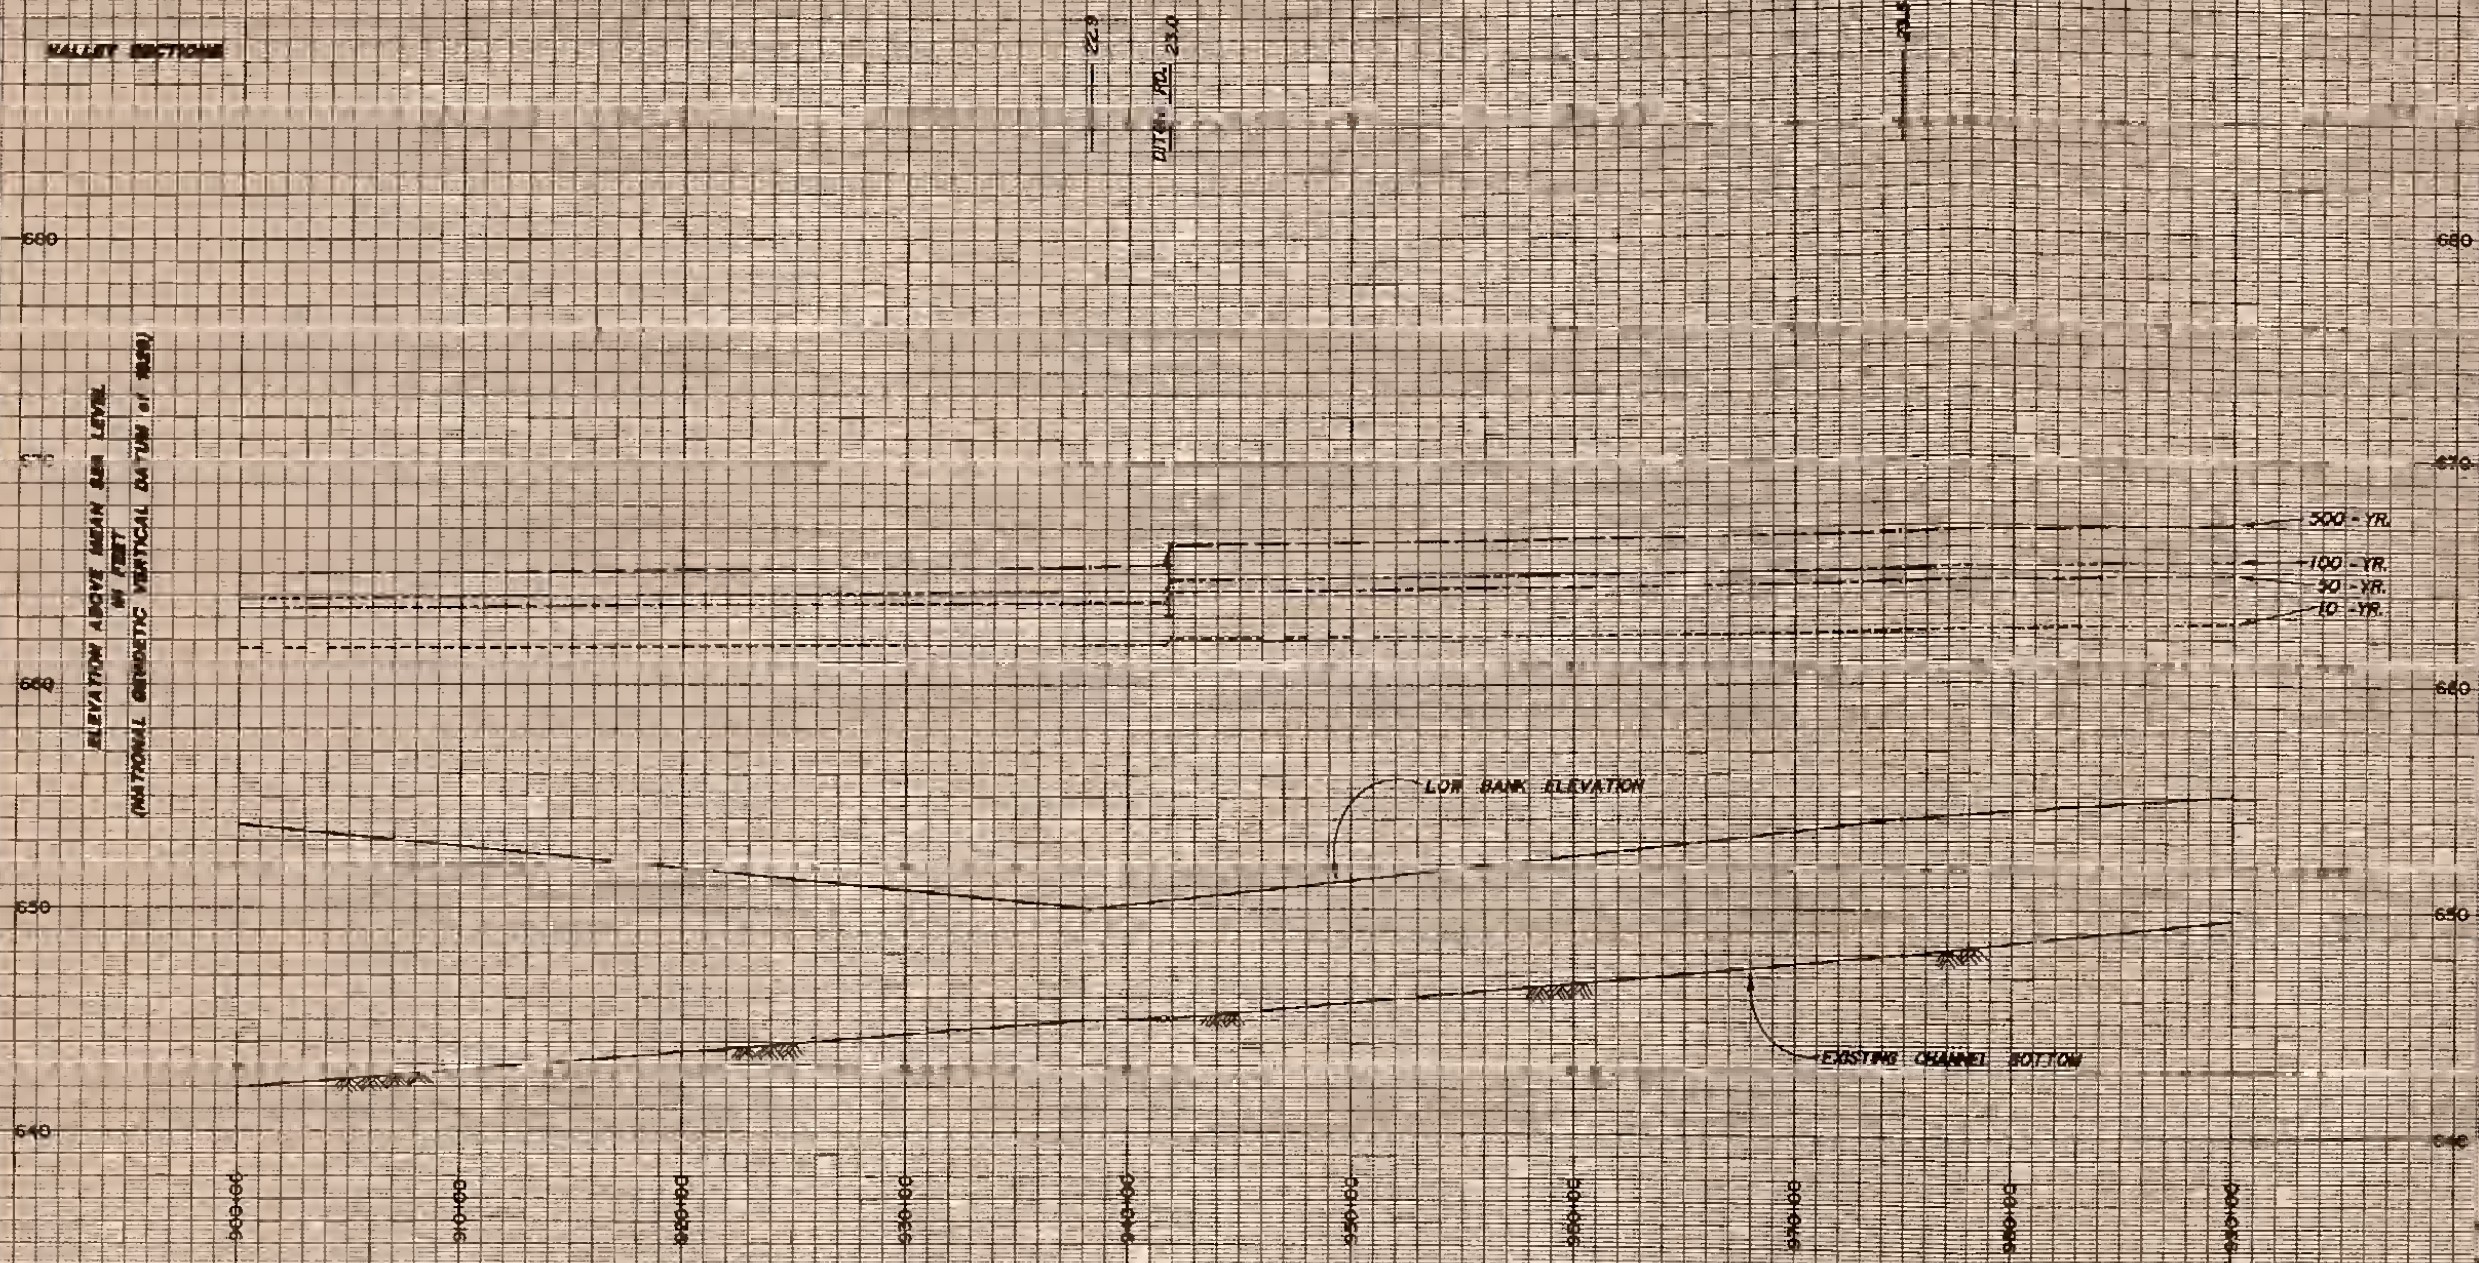
VALLEY SECTIONS

NOTE:
Additional field measured cross-sections may be needed to verify the water surface profile between the cross-sections used in this report. When the difference in the elevation of the channel bottom between cross-sections exceeds 2/3 the depth of flood flows, variations in the channel bottom can cause significant changes in the flood profile.

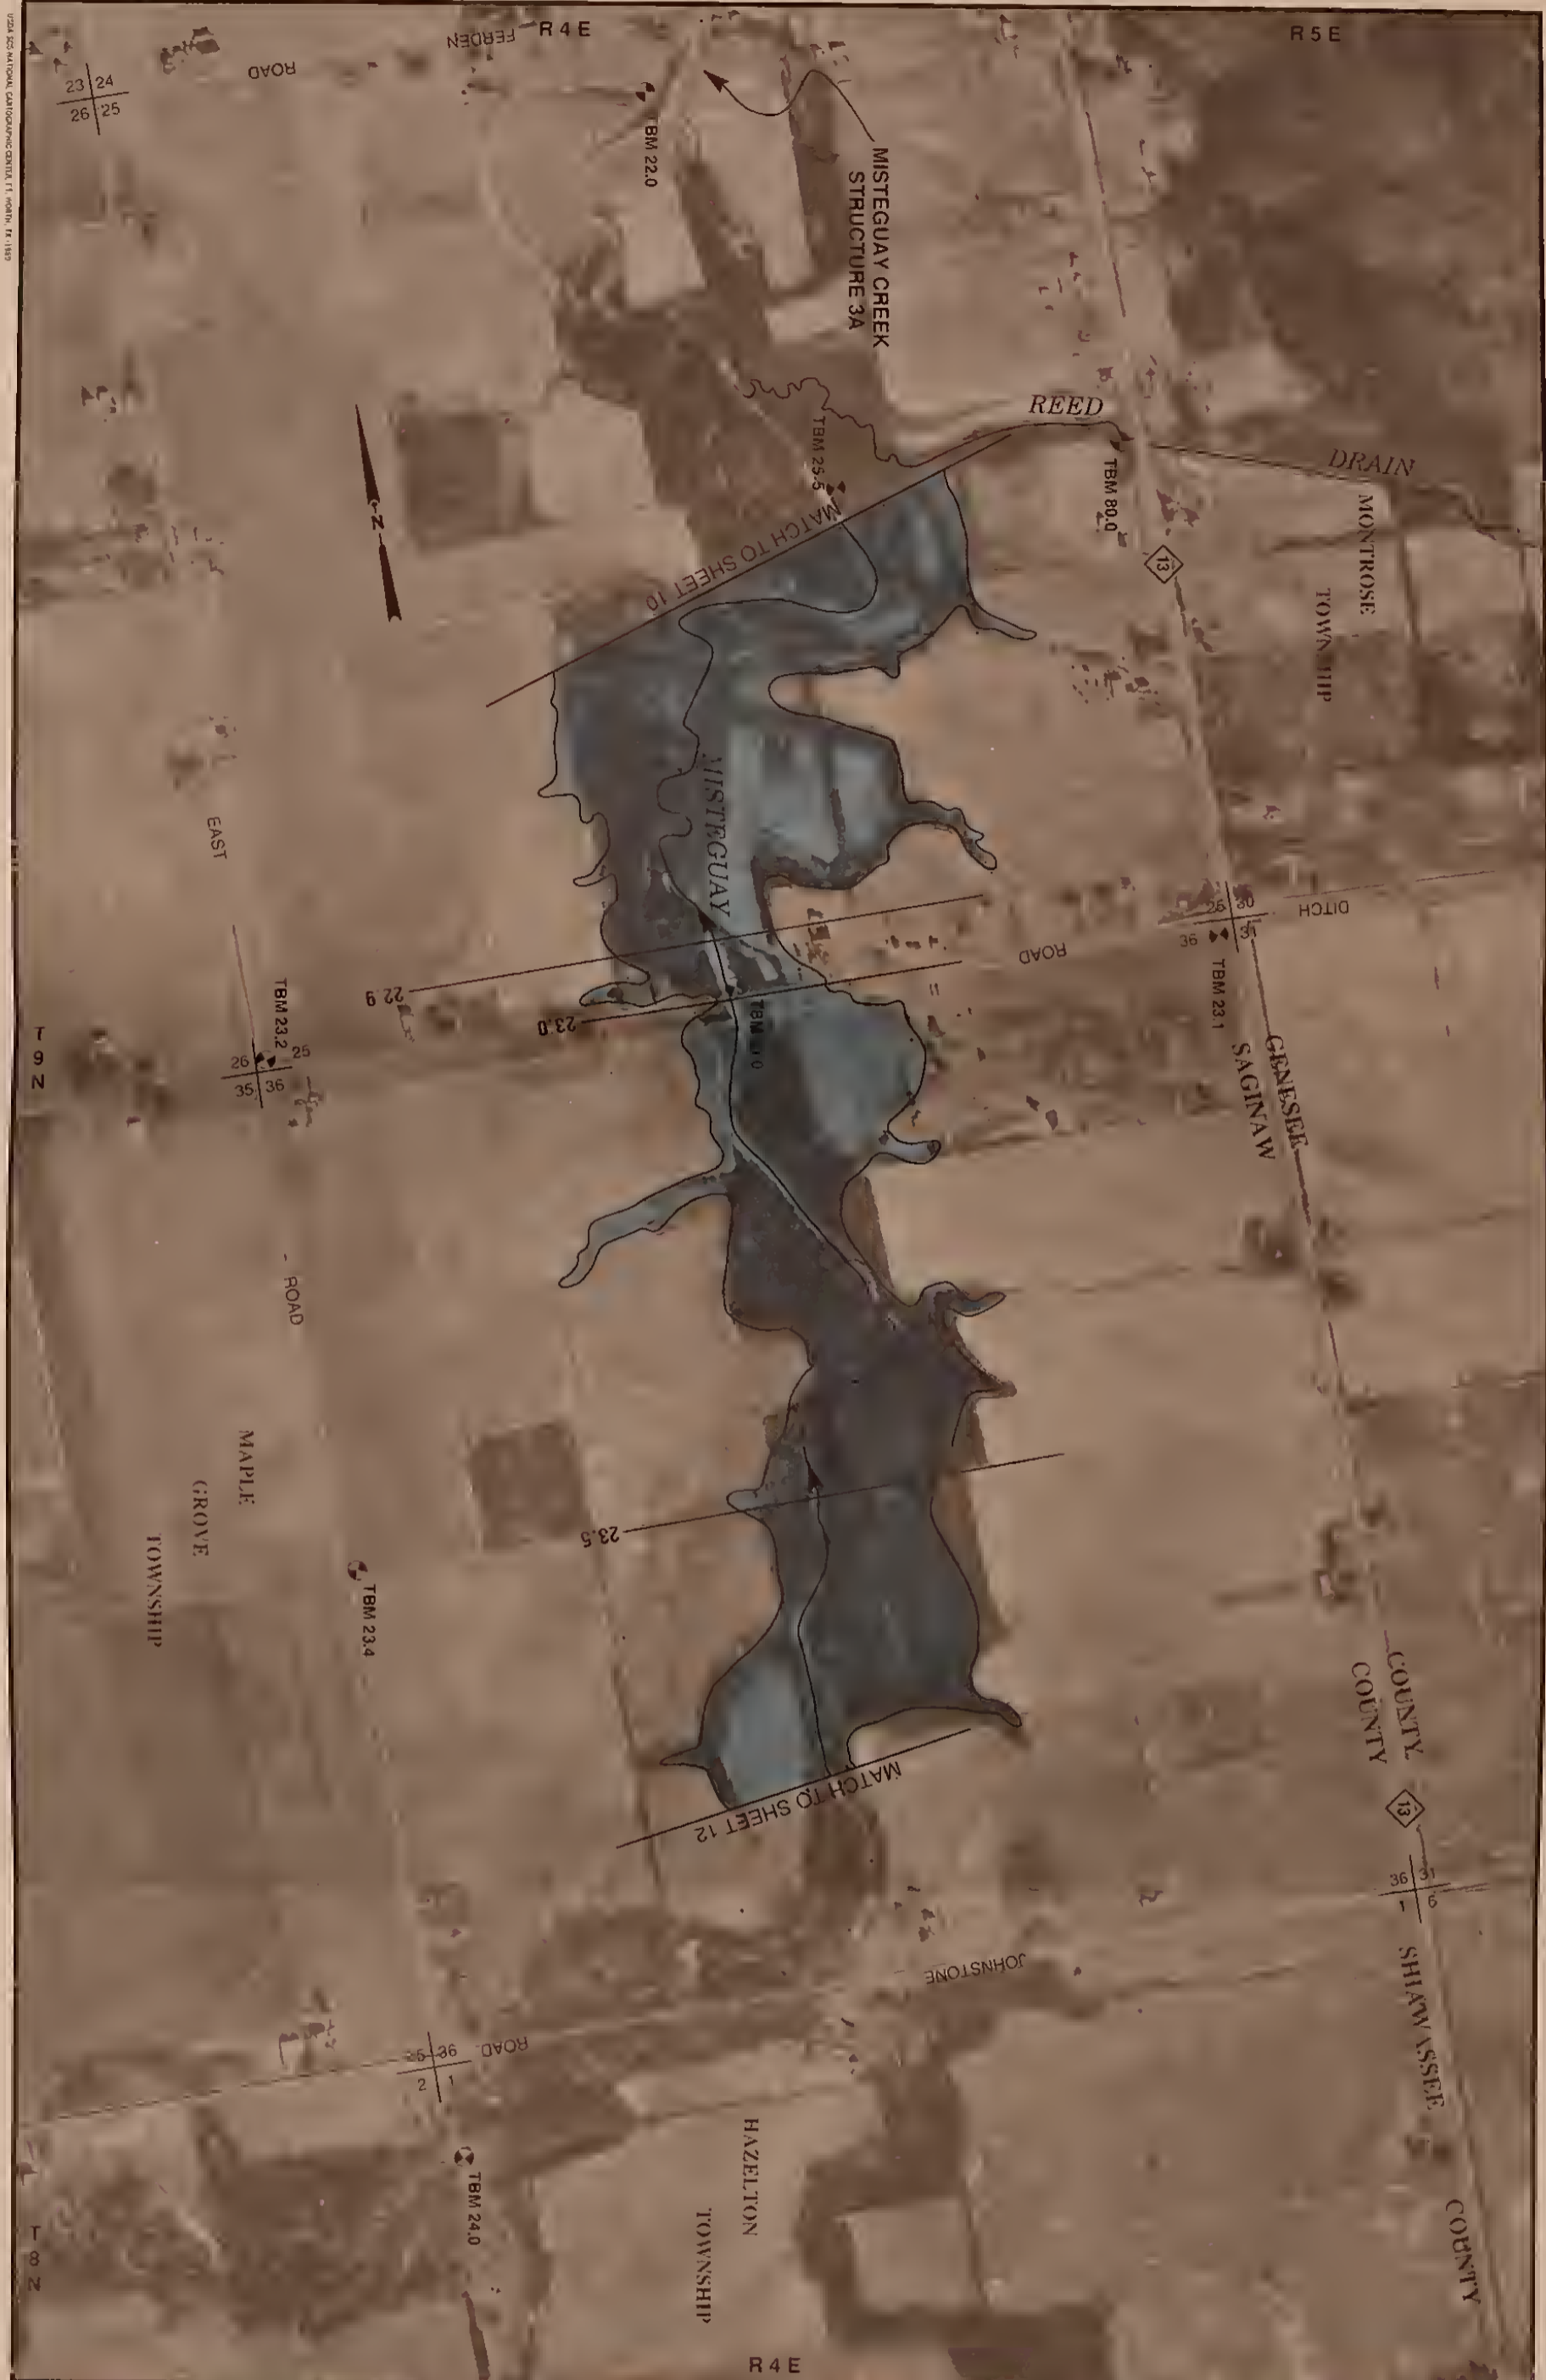
LEGEND		NOTE: LIMITS OF FLOODING SHOWN MAY VARY FROM ACTUAL LOCATIONS ON THE GROUND AND DUE TO INHERENT AERIAL PHOTOGRAPHIC DISPLACEMENT THE PHOTOGRAPHIC IMAGE MAY VARY FROM TRUE GROUND LOCATION.	SCALE 0 800 1600 FEET 0 200 400 METERS APPROXIMATE January 3, 1988 Photography From Abrams Aerial Survey Corp.
100 Year Flood Hazard Area	500 Year Flood Hazard Area		
8.0 Valley Section Location	TBM 9.1 Temporary Bench Mark		
U.S. DEPARTMENT OF AGRICULTURE SOIL CONSERVATION SERVICE MISTEGUAY CREEK FLOOD PLAIN MANAGEMENT STUDY GENESEE, SAGINAW AND SHIAWASSEE COUNTIES, MICHIGAN		FLOOD HAZARD AREA MISTEGUAY CREEK

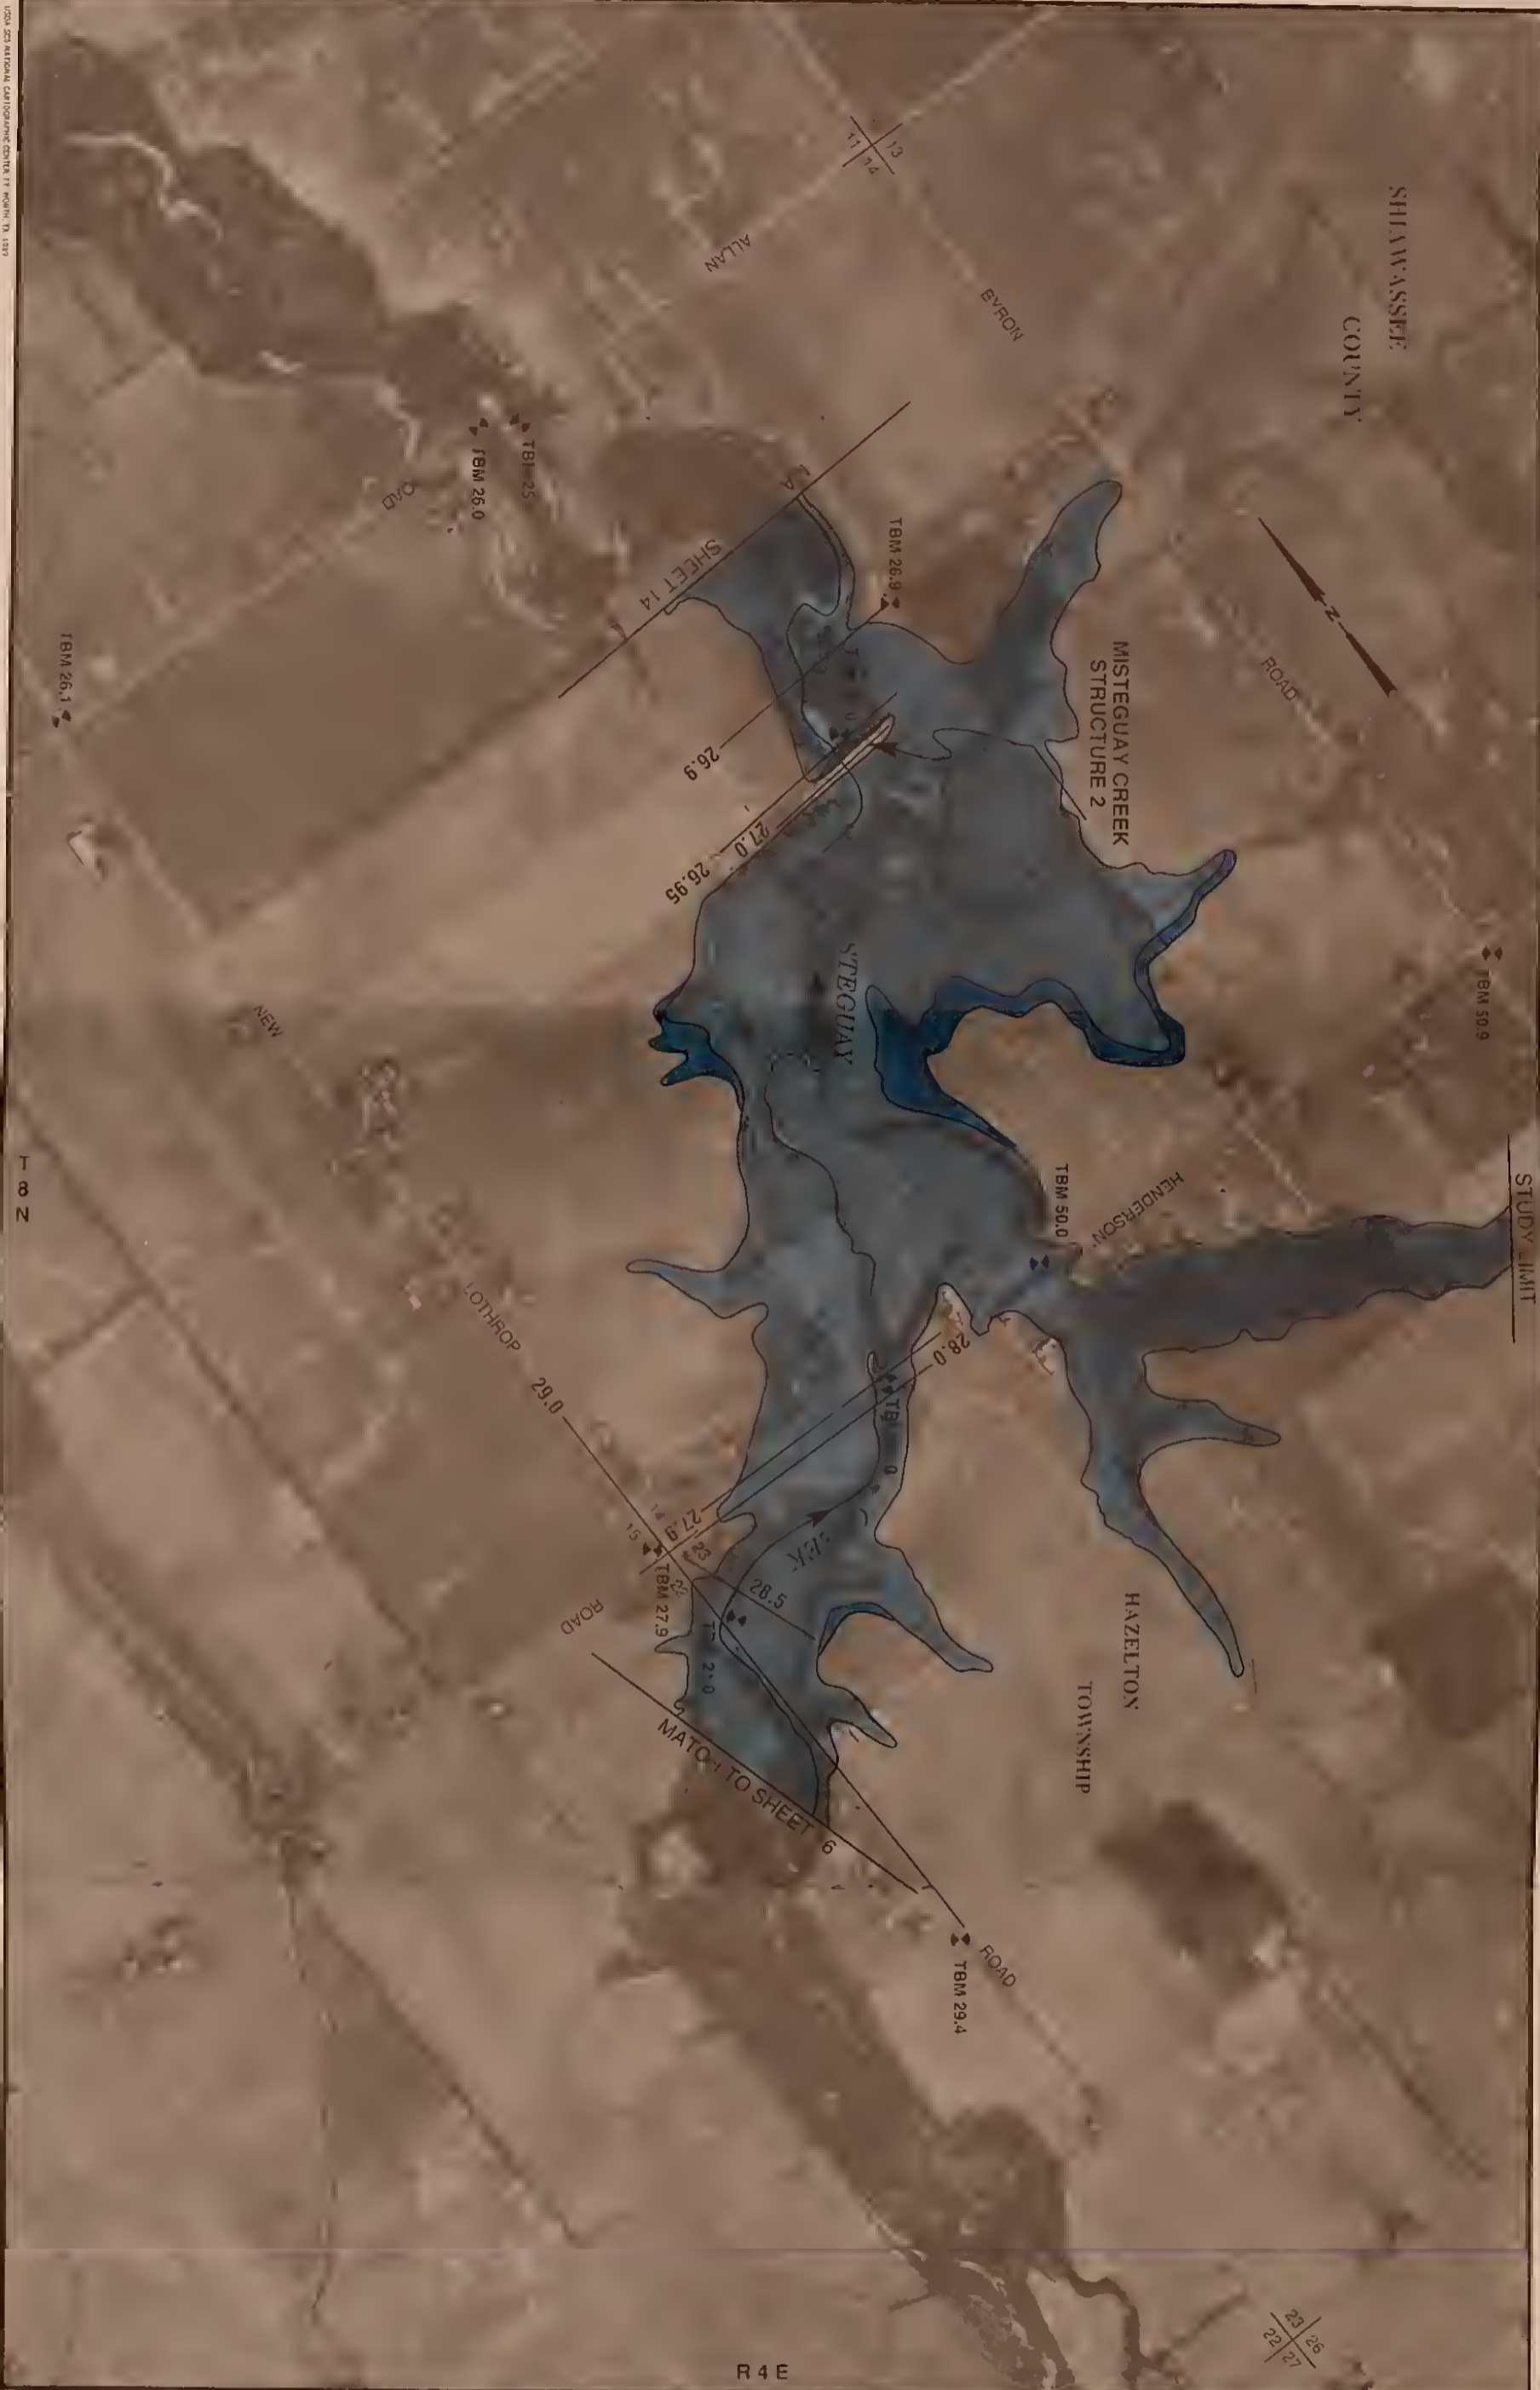
LEGEND		<small>NOTE: LIMITS OF FLOODING SHOWN MAY VARY FROM ACTUAL LOCATIONS ON THE GROUND AND DUE TO INHERENT AERIAL PHOTOGRAPHIC DISPLACEMENT THE PHOTOGRAPHIC IMAGE MAY VARY FROM TRUE GROUND LOCATION</small>	SCALE 0 800 1600 FEET 0 200 400 METERS APPROXIMATE January 3, 1988 Photography From Abrams Aerial Survey Corp.
100 Year Flood Hazard Area	500 Year Flood Hazard Area		
8.0 Valley Section Location	TBM 9.1 Temporary Bench Mark		
U.S. DEPARTMENT OF AGRICULTURE SOIL CONSERVATION SERVICE MISTEGUAY CREEK FLOOD PLAIN MANAGEMENT STUDY GENESEE, SAGINAW AND SHIAWASSEE COUNTIES, MICHIGAN		FLOOD HAZARD AREA MISTEGUAY CREEK

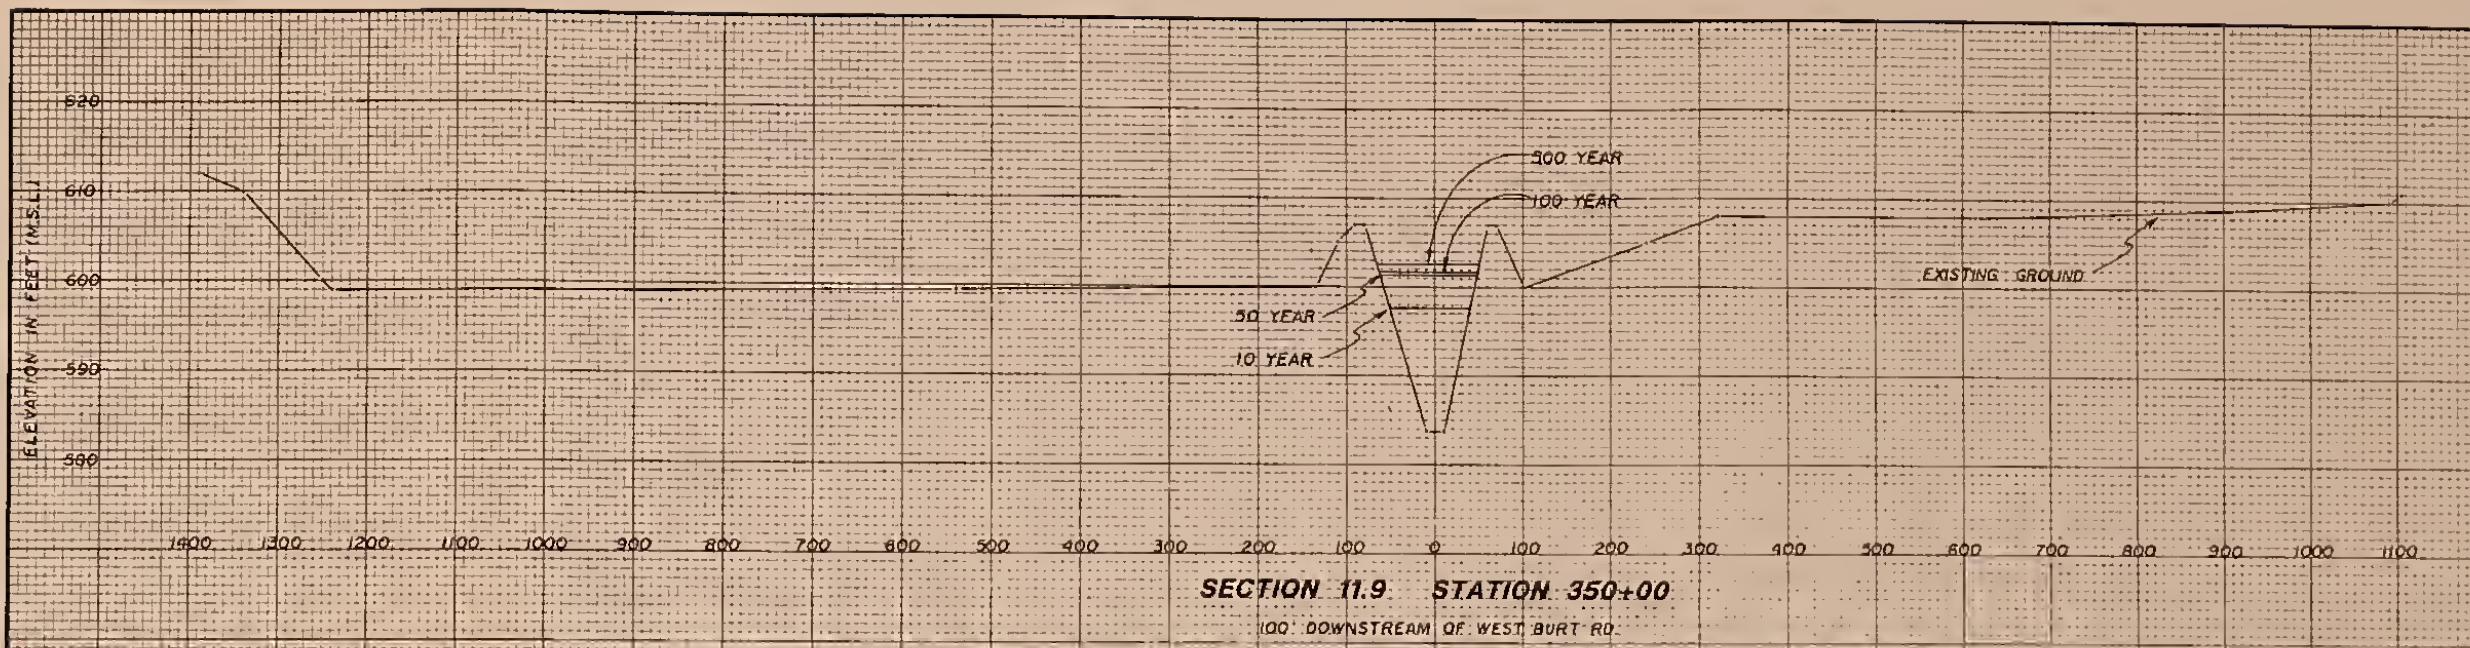
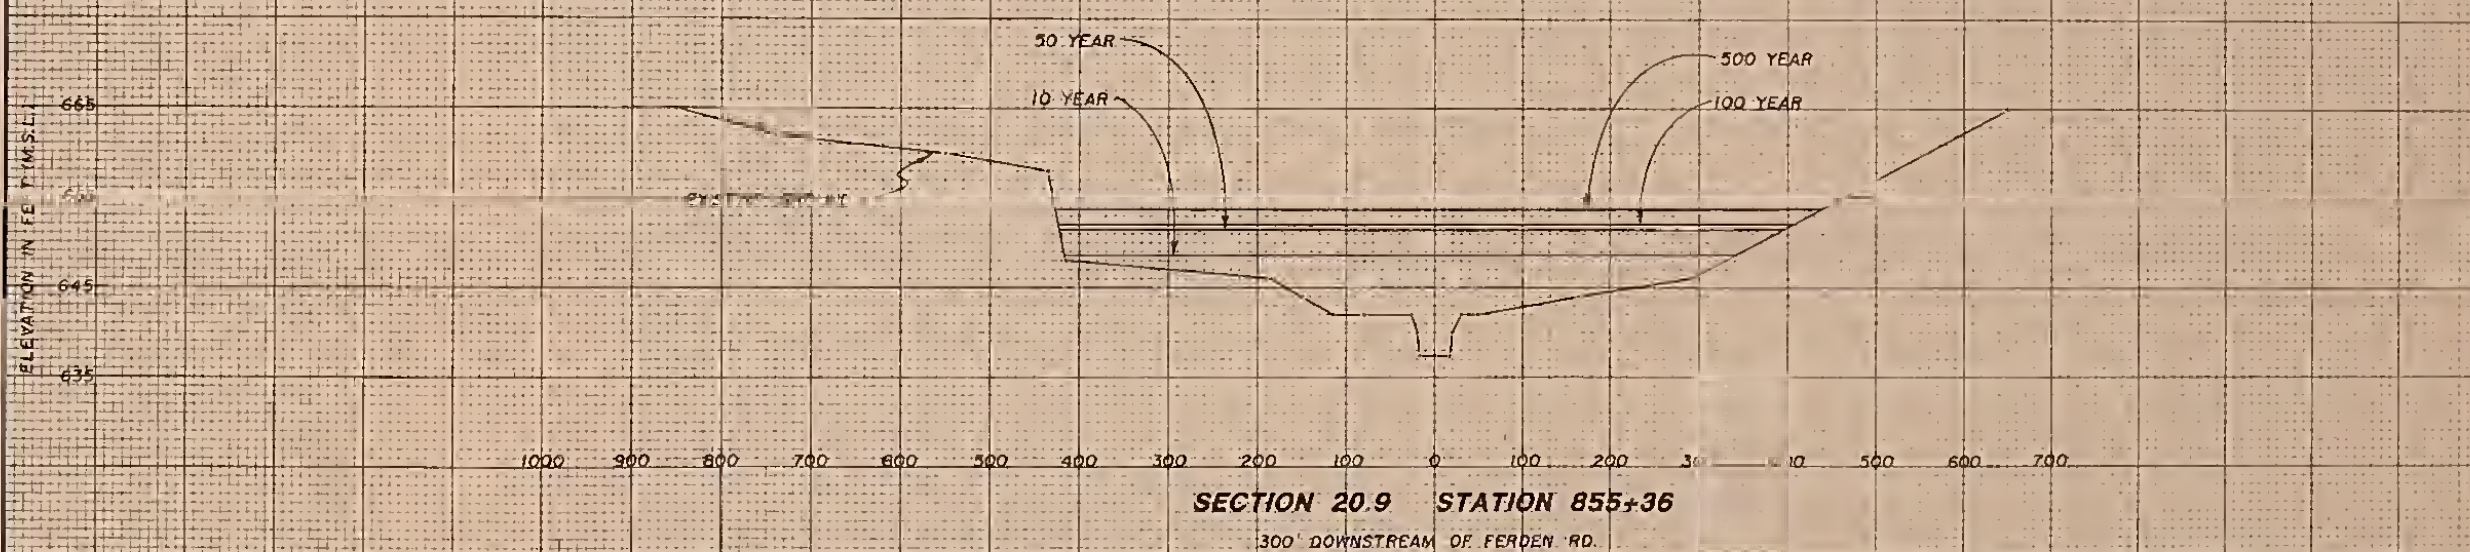
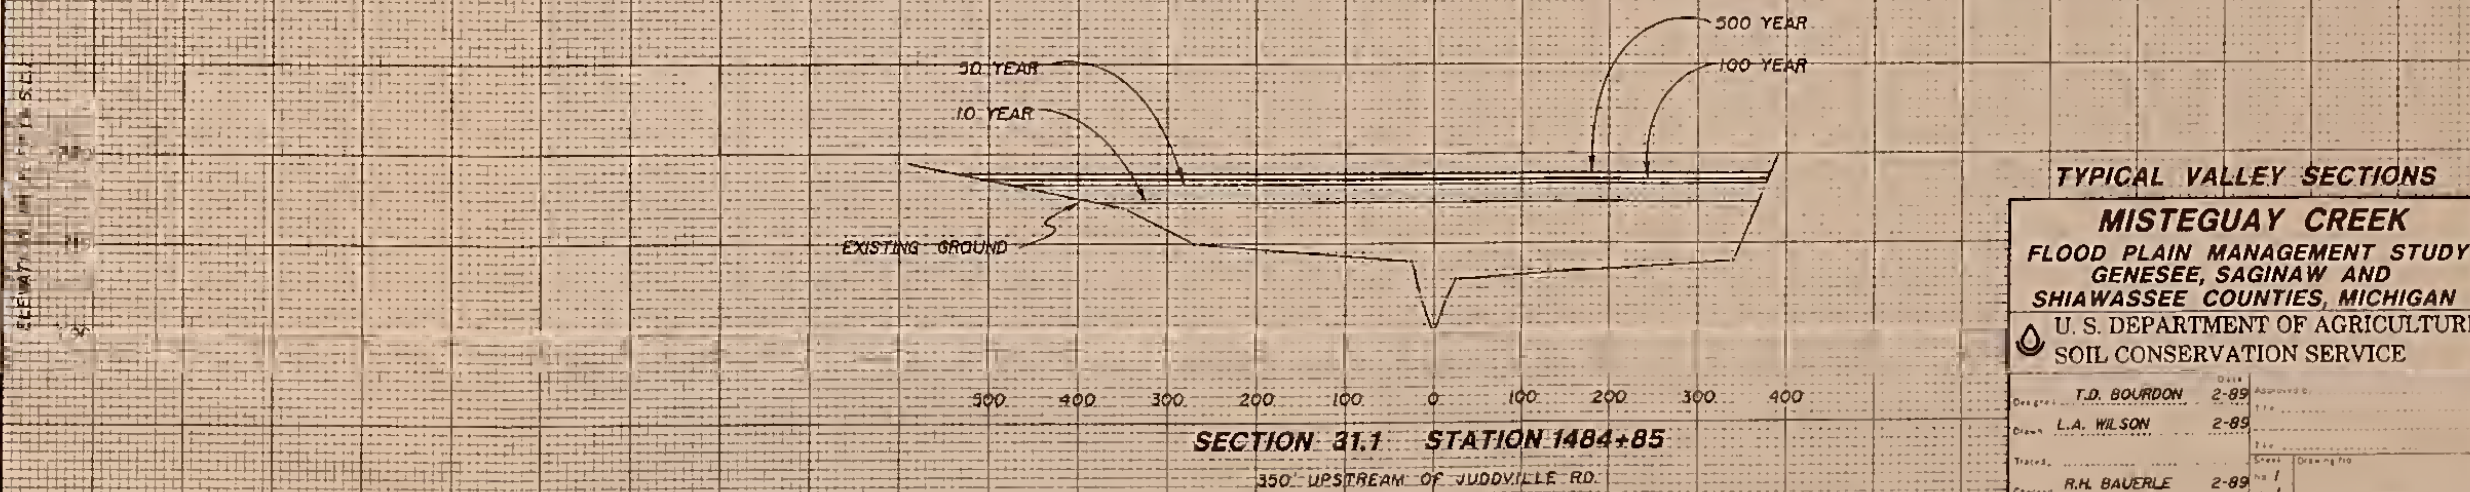
TYPICAL VALLEY SECTIONS

MISTEGUAY CREEK
FLOOD PLAIN MANAGEMENT STUDY
GENESEE, SAGINAW AND
SHIAWASSEE COUNTIES, MICHIGAN
U. S. DEPARTMENT OF AGRICULTURE
SOIL CONSERVATION SERVICE

Typical valley sections shown in Appendix B indicate the effects of the 4 floods. Flood discharges used for computing high water profiles in the study area are shown in Table 3 in Appendix C. Table 4 in Appendix C shows flood elevations at each of the valley sections for present conditions.
